Common as M

We welcome Alec Kermotschuk, who is to keep us in touch on the preservation and restoration of a 1972 Shelvoke & Drewry Ltd refuse wagon. This vehicle is in the process of being restored at this very minute! The wagon is expected to be finished and back to its former glory later in the year and, through Alec's work, we will keep you in full touch with progress on this unusual project.

Alec Kermotschuck continues the story of Bradford's S&D refuse wagon

Alec Kermotschuk concludes the restoration on Bradford Council's Shelvoke & Drewry TBN refuse wagon.

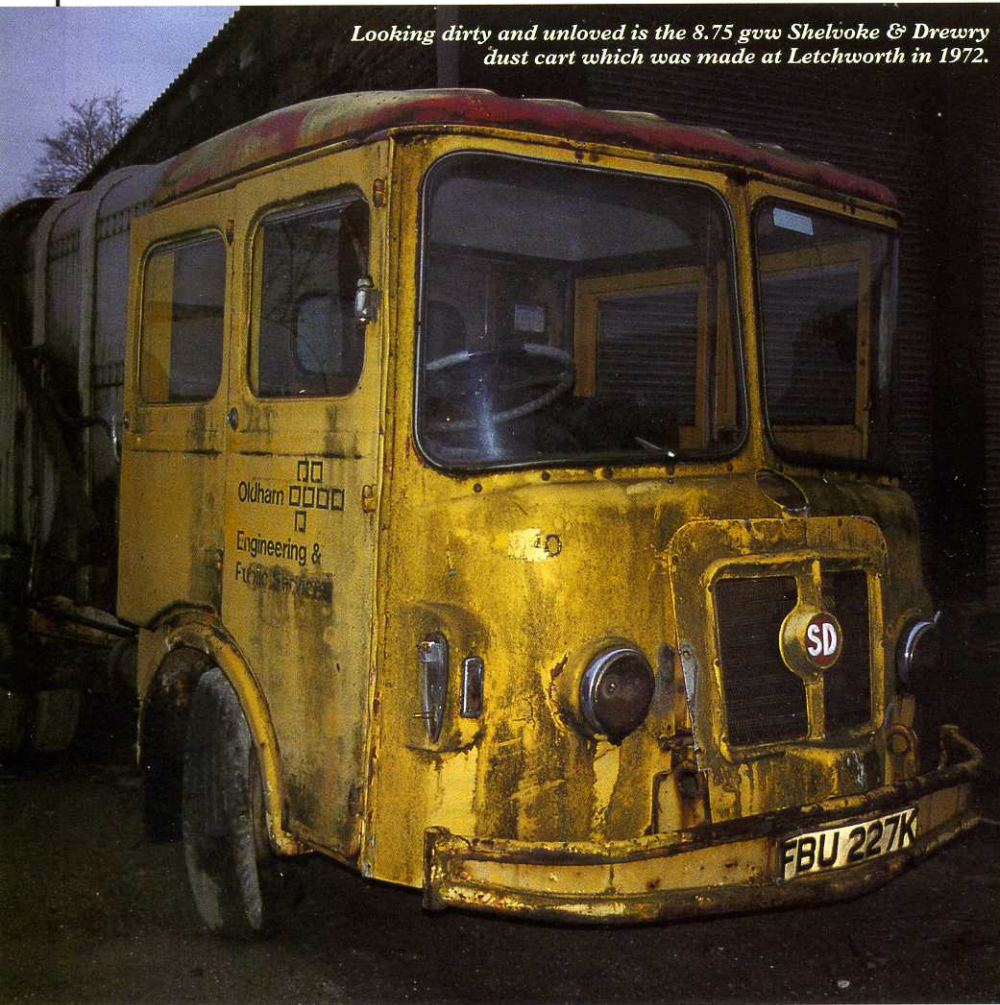
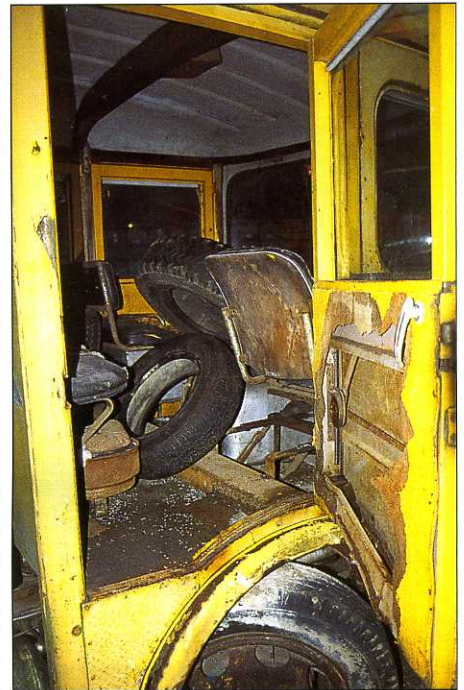
Looking dirty and unloved is the 8.75 gvw Shelvoke & Drewry dust cart which was made at Letchworth in 1972.

The rear door compartment which was used by the dust men has had the door panel ripped off and the spare tyre certainly does not fit this lorry.

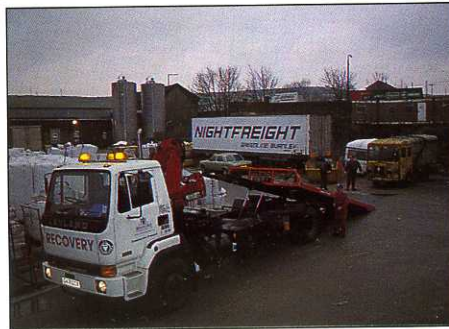
Down goes the back of the Leyland Freighter and it is all systems go in the loading of the dust cart.

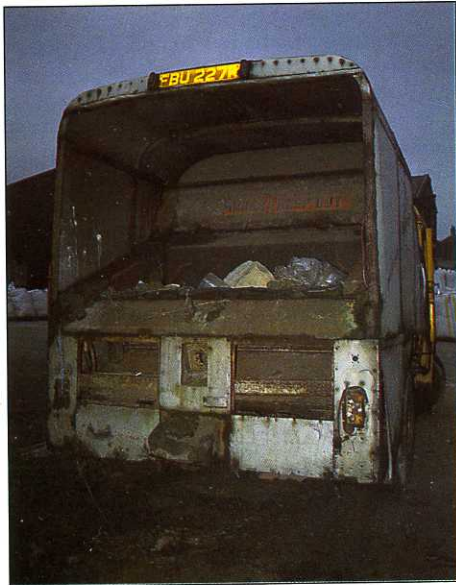
There are plenty of things hidden inside the dustcart that will keep the apprentice busy for a few hours cleaning it out!

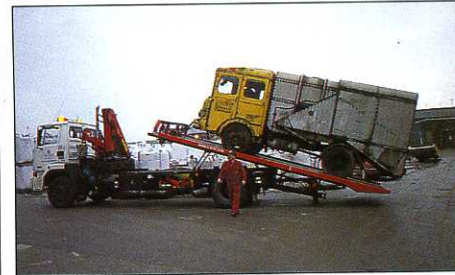
The well equipped Freighter, which includes a Hiab, with the S&D dust cart in mid air!

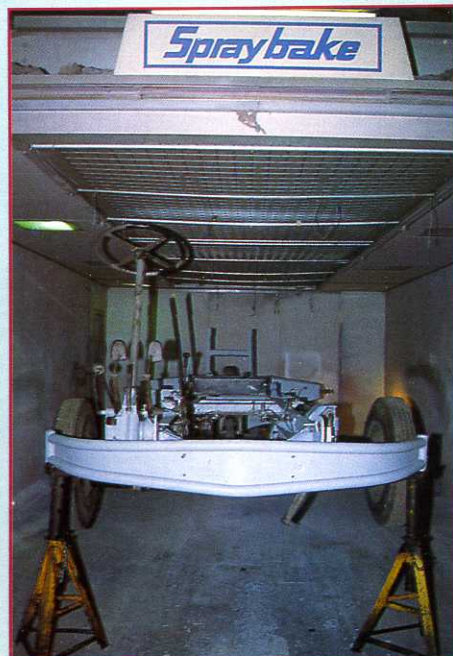
The chassis propped up on axle stands in the oven prior to the preparation and paint work commencing at Hatfields Motors. Notice the wheels turned inside out - this gave Frank the painter easier access to the chassis.

The chassis frame was thoroughly sandblasted and primed ready for the top coat. The paint used was a two-pack low bake professional PPG black finish, applied by spraying at a pressure of 44psi at a temperature of around 60°F obtained from working in the pre-heated oven. Once the spraying had been done, the painter, Frank himself in this instance, then left the oven, re-closed the doors and turned up the heat to a temperature of about 70°C for a period of 45 minutes. Two top coats were applied using the same method. While this was being done I went down to the workshops at Shearbridge to have a chat with Allen Freer, the project fitter. I returned later to see the finished chassis.

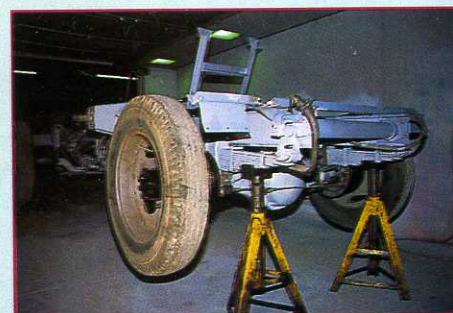
The rear of the chassis, taken looking out of the oven.

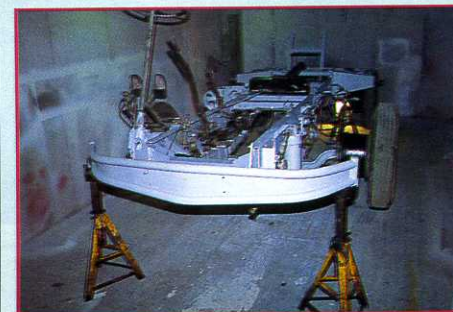
The chassis just prior to the start of the painting.

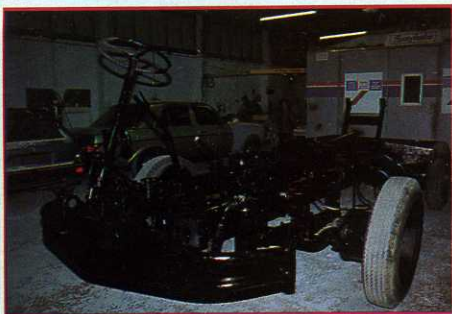
Transformed! The chassis after repainting and baking. There is a lovely gloss finish to the paintwork - well done Frank!

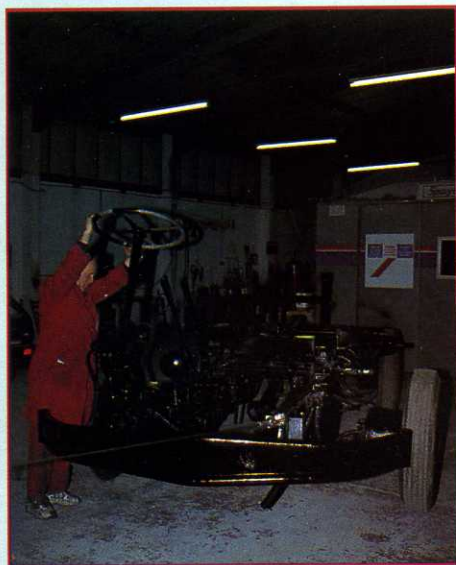
Allen Freer uses an unorthodox steering position while the chassis is winched up on the transporter.

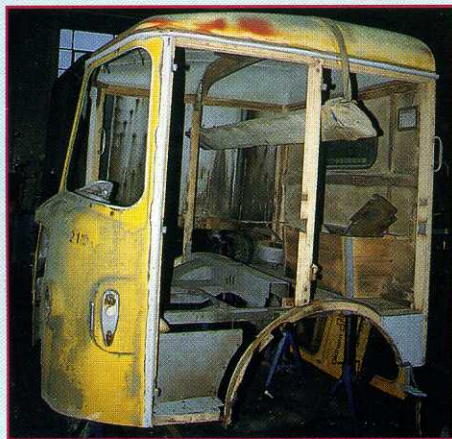
The cab on its return from the sandblasters and awaiting repairs to the timber work. There's still a long way to go yet!

The cab's original timber frame was rotten in places, especially the lower sections. These have been replaced exactly as the manufacturer's specification by the council's own joiner. The metal panels on the lower half of the doors have been cut out and replaced due to corrosion, but generally the doors were in pretty good condition, needing minimal work to make them serviceable once more. By good fortune all the original glass in the cab windows will be reused again once the cab has been painted.

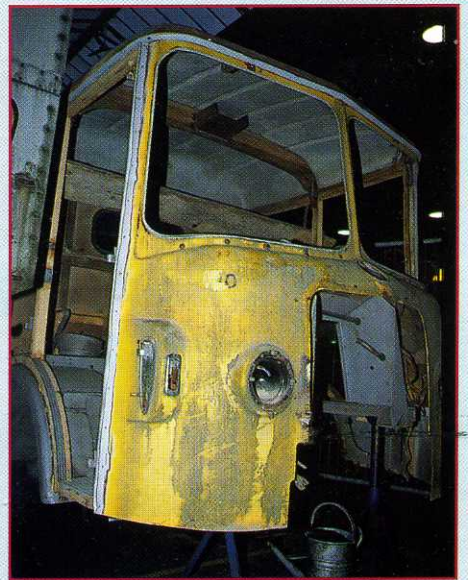
The basic structure had withstood the ravages of time quite well.

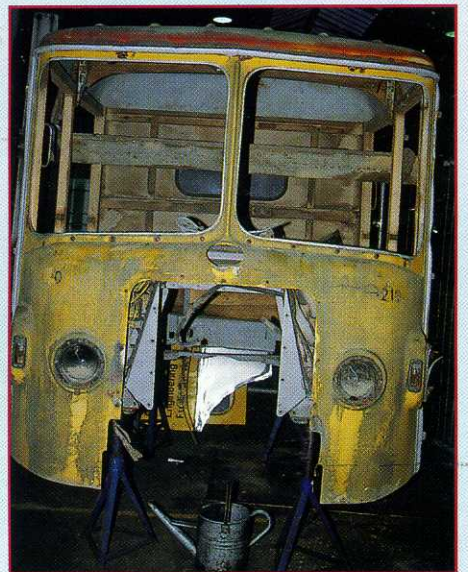
Front view of the cab before repairs commenced.

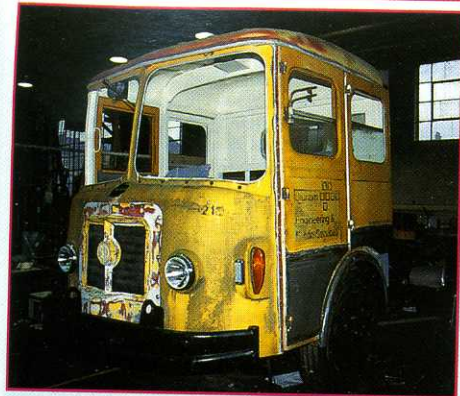
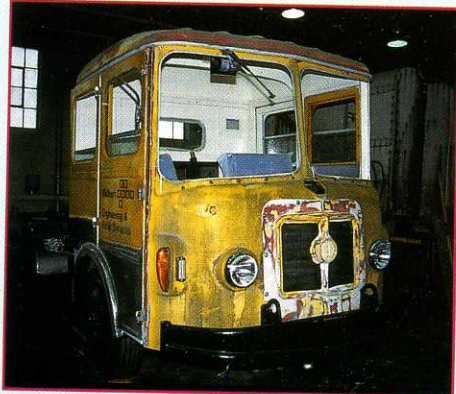
These two shots show the cab from the near and off sides, with the new sections visible in the lower doors.

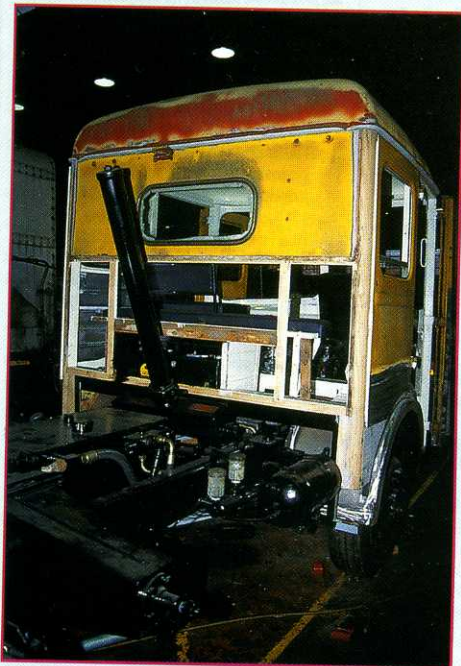
The cab is now reunited with the chassis and the S&D begins to take shape once more. Note the fine workmanship evident on the chassis.

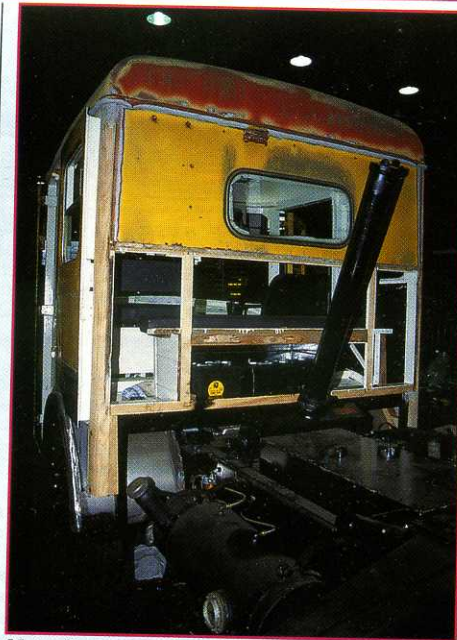
Note the new ash framing in the cab.

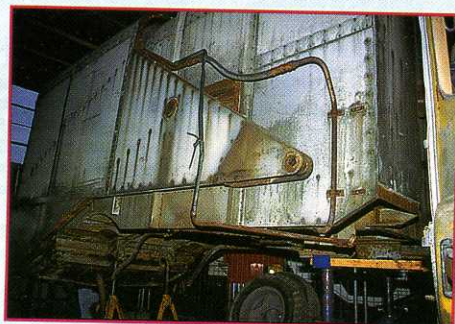
A view of the body propped up on axle stands awaiting repairs.

Attention now turned to the main body. This was in need of extensive repairs because of corrosion to the steel frame, especially the underneath sections. It was decided from the outset that all the replating would match Shelvoke & Drewry's original specification, in keeping with the entire restoration. The first stage was to have the entire body shot-blasted, to enable Allen Freer to determine the extent of the work needed.

After examination the steel floor panels and loading hopper were replaced by new fabrications produced by a local sheet metal shop, and these were welded in place on site. New rear twin folding steps have

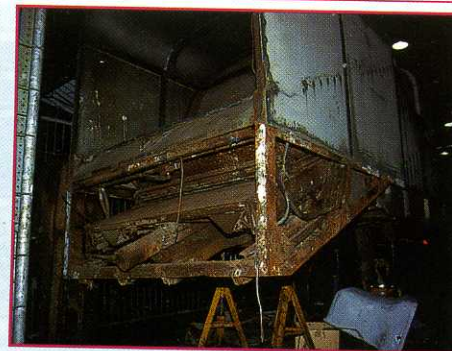
The underside of the loading hopper, revealing the extent of the corrosion to the basic steel structure under the aluminium panels.

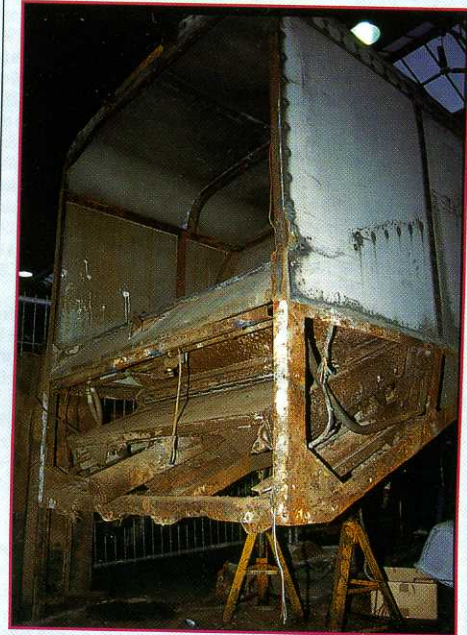
Not a pretty sight! All the corroded areas were replaced.

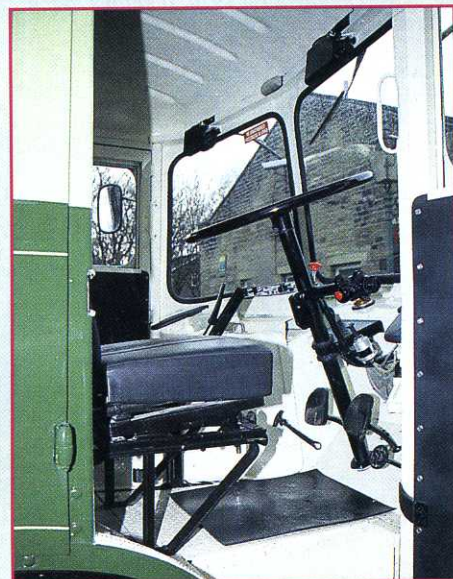
A view of the driver's position. The interior of the cab now looks better than new.

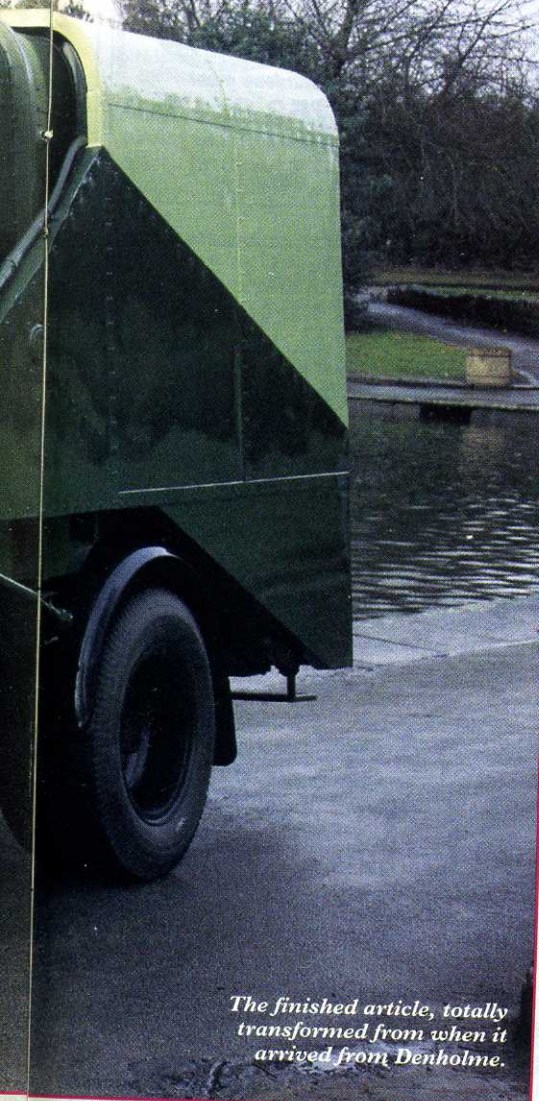
The finished article, totally transformed from when it arrived from Denholme.

Now at last the main painting could begin. The upper body and loading hopper, together with the top section of the cab, is finished in a light green called 'Eau de Nil', while the lower sections are finished in a darker 'Brunswick' green, and these colours set the S&D off delightfully. This was the original livery of the council's vehicles working in the Keighley District when the vehicle was in use, as Bradford itself did not own vehicles of this type at that time. The cab was hand painted by David Morton, a skilled coachpainter, who used to work for the council's transport paint shop. As for the coat of arms and associated lettering on the door panels, these were hand painted by specialist signwriter 'Brian the Brush' of Bradford and are again accurate for the period when these vehicles were used around the area. Unfortunately there are very few craftsmen around these days that can do this skilful artwork, as nowadays most

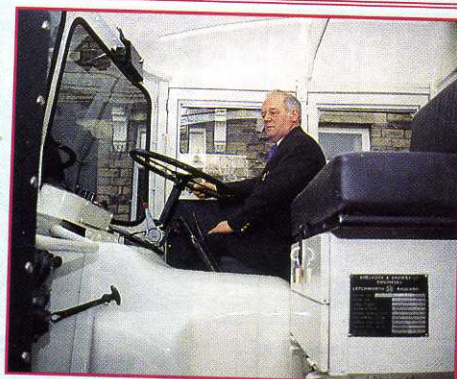
Allen Freer in the driving seat. Note the spacious cab interior and excellent visibility – essential in the narrow streets and lanes of Bradford.

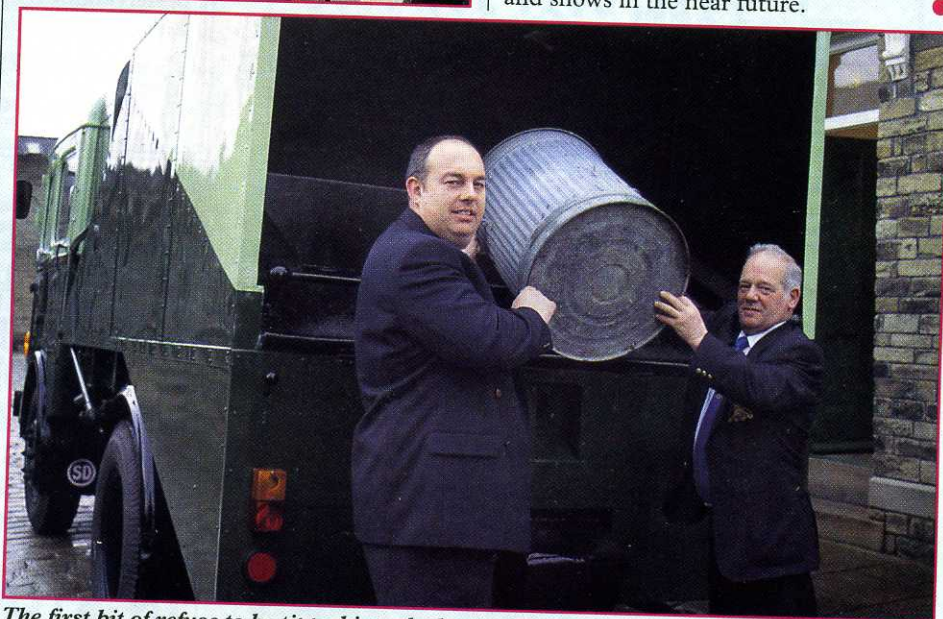
The first bit of refuse to be tipped into the back of the S&D's loading hopper since the restoration. Terry Pycroft (left), assistant workshop manager at Shearbridge Depot, and project fitter Allen Freer put the S&D back to work.

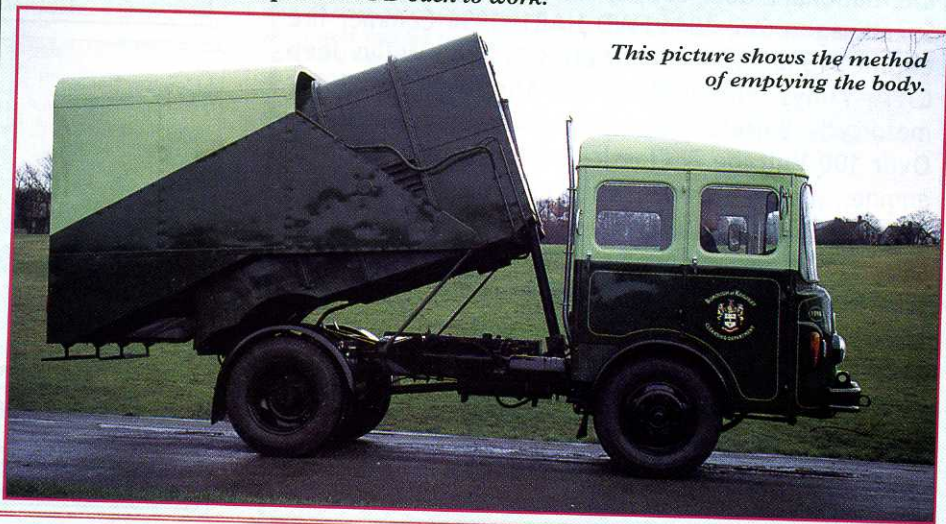
This picture shows the method of emptying the body.

The rest of the bodywork was cleaned ready for repainting. It should be noted that the body operates on the 'jack-knife' principle - in other words the body splits open in the middle and allows the refuse to fall out into the tip. This operation was performed hydraulically, and all the hydraulic cylinders, seals and pipes were also overhauled and renewed where necessary.

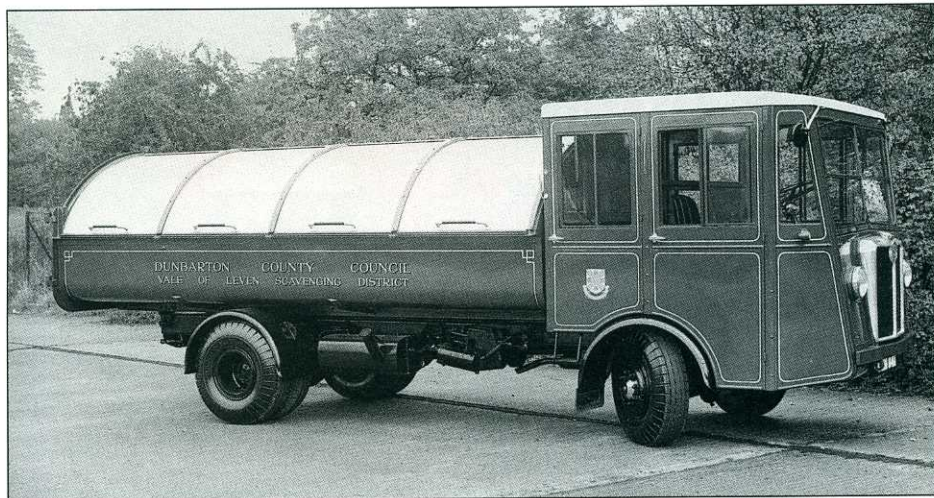
1953 W-type with conventional side loading dustcart bodywork.

The replacement for the Freighter also boasted small road wheels but at that point the similarity ended. The new model, designated the W type, had an engine in the conventional position and a normal gearbox as well as a steering wheel (hence the designation 'W'). There was a proper cab rather than the 'driver only' version offered on the original Freighters. Production commenced in 1947 and the

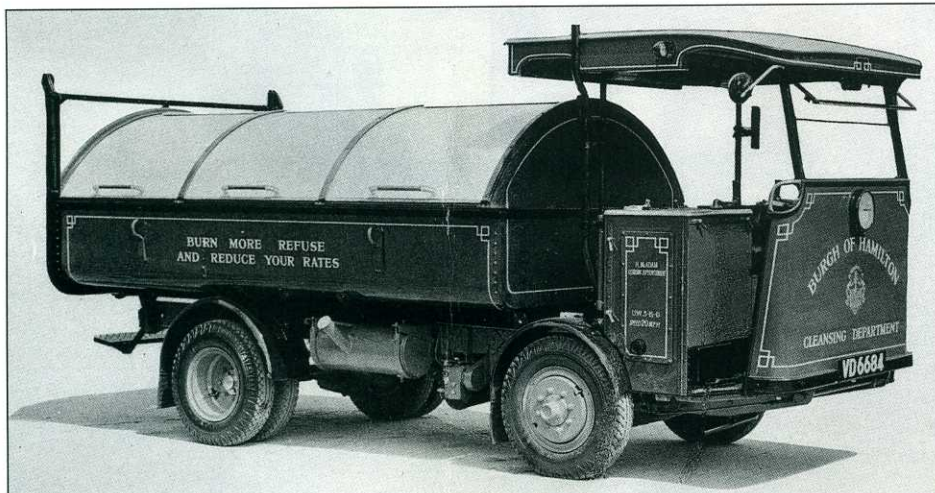
One of the late tiller steered tipper from 1936. This one for Hamilton had a demountable body.

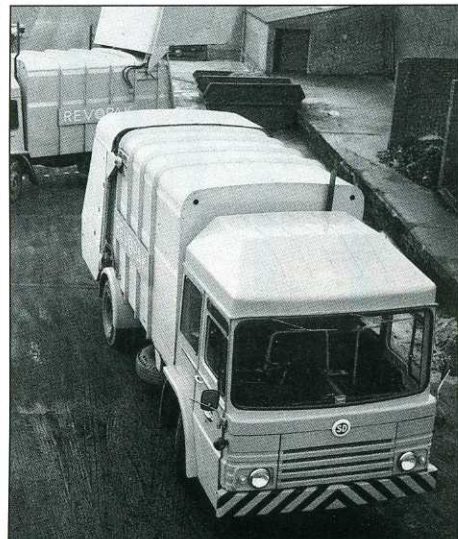
S&D N series was introduced in 1972. These are fitted with Revopak bodies.

confuse things the T cab could still be fitted to the narrow bodied N chassis, the resultant vehicle being called the NN type. The new N series relied on the Motor Panels cab, modified to suit its use as a municipal vehicle, and generally came with various versions of the Revopak body.

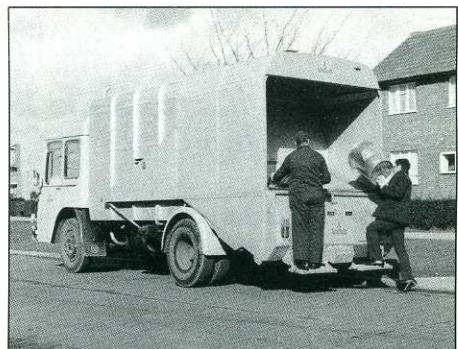
Loading a 1973 Pakamatic on a S&D chassis but also available on proprietary types.

The TN was the narrow version and came with a four-cylinder Perkins engine, against the Leyland engine fitted in its big brother. Models were made available with Pakamatic compaction bodies (based on the French Semat Rey principles) or fore-and-aft tippers. The early Pakamatic bodies had a compaction mechanism

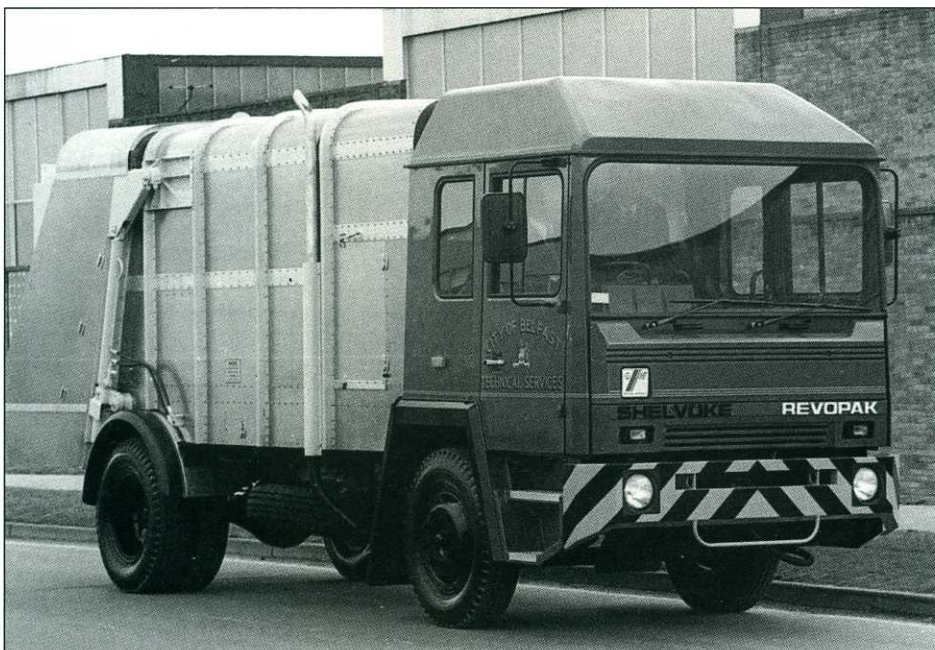
The P series was new in 1978 to replace the N series.
